Final report

Immersion testing on coated and uncoated panels in ozone treated water

Desmi Ocean Guard

4C 1303031- 433373 DSP/BBJ 2012.01.31

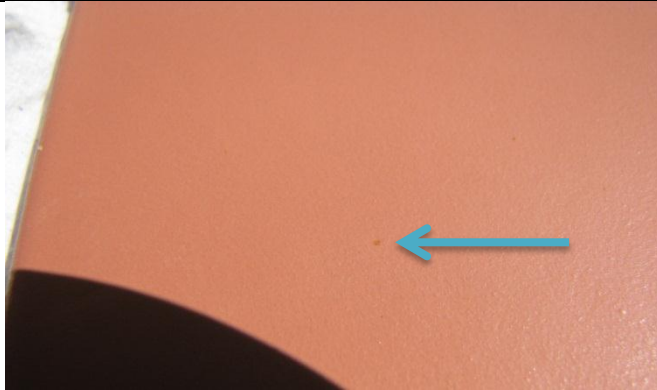
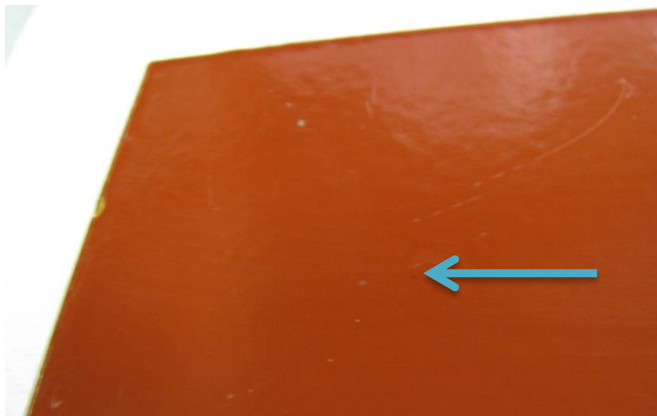
1 week: Panel 19, rust mark

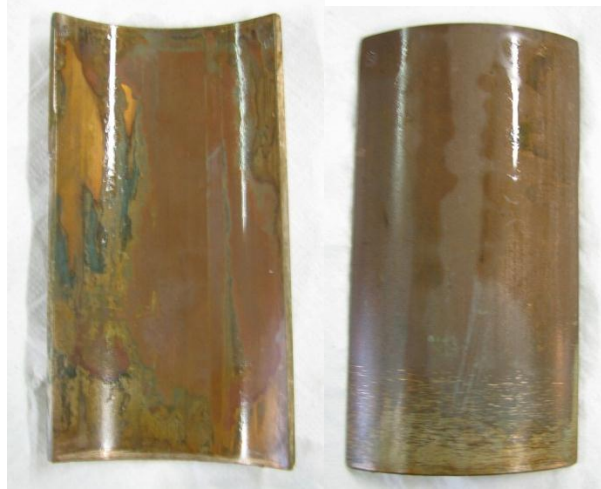
1 week: Panel Cu2, rust development

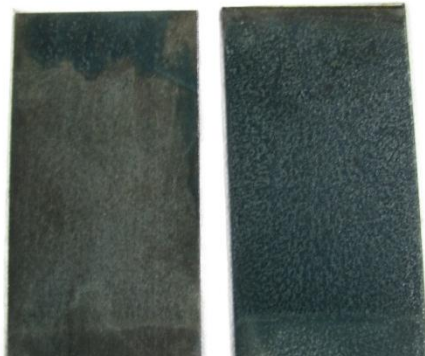
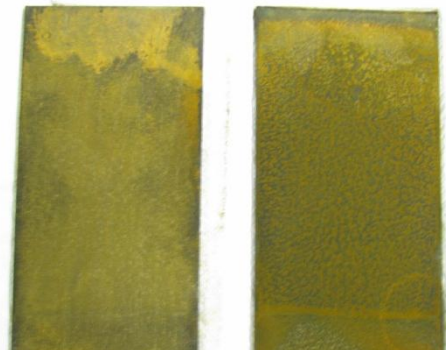
1 week: Panels Sa1 and Sa2

Right after removal from water

Approx. 10min after removal from water

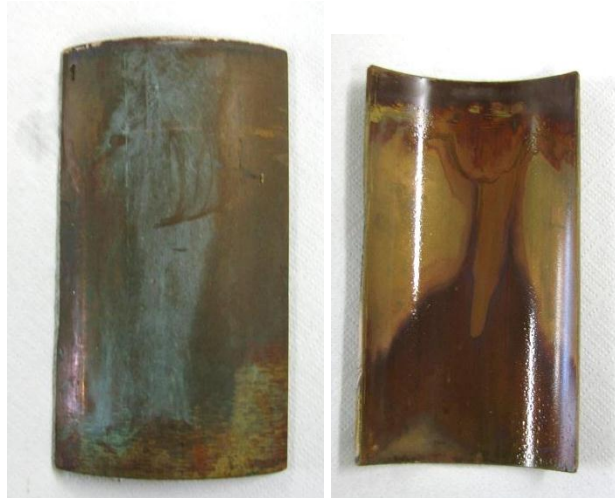
Panel Cu1, rust development

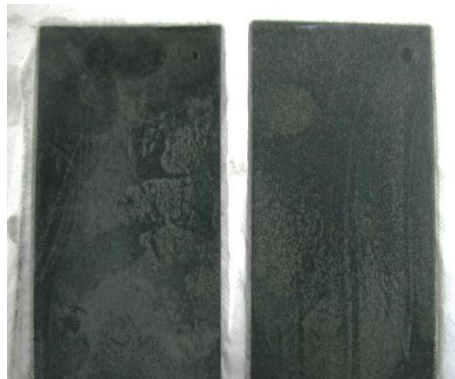
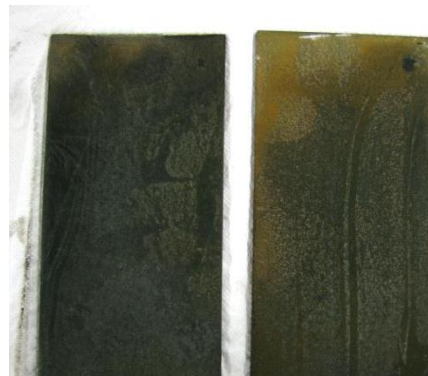
Right after removal from water
Panels Sa3 and Sa4

Approx. 5 min after removal from water

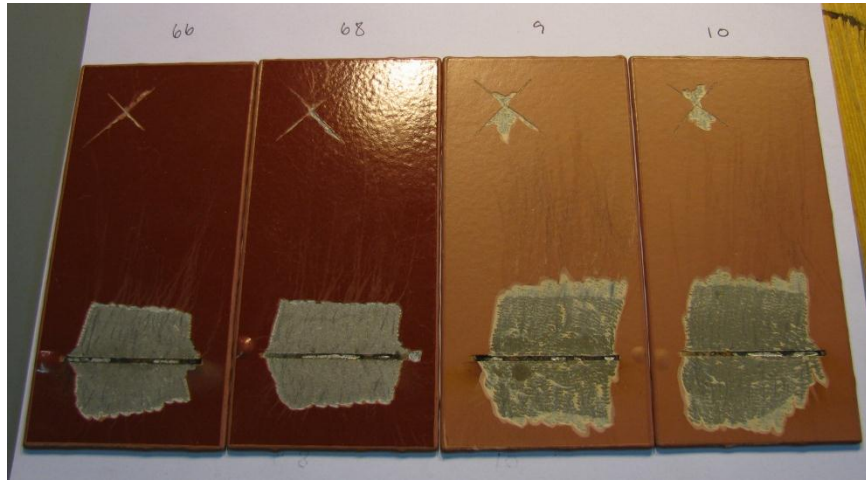
Panels 66- 68 – 9 – 10 after removal of loose paint.

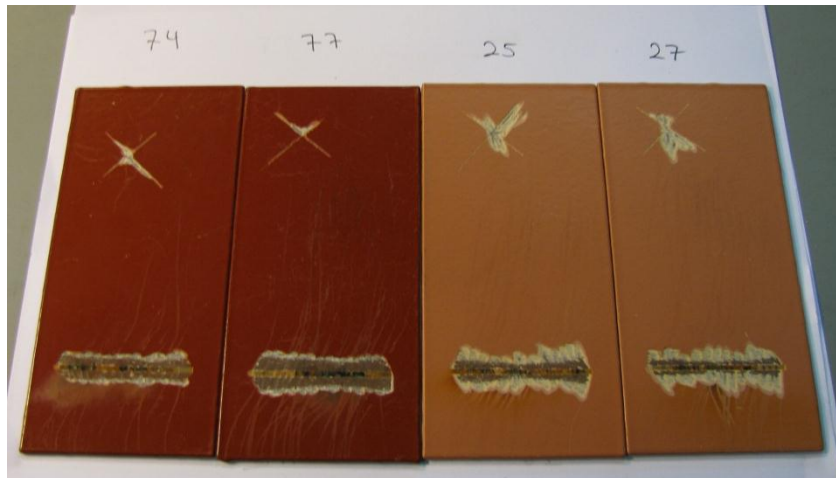
Panels 74 – 77 – 25 – 26 after removal of loose paint

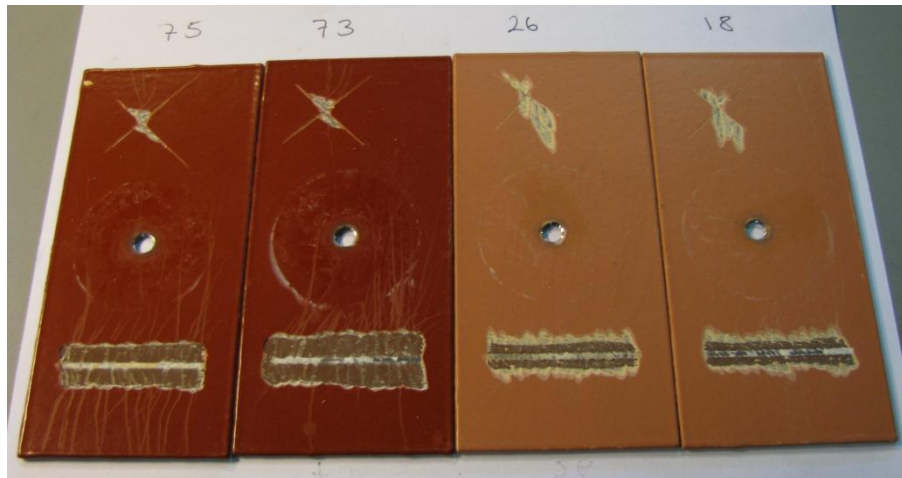
Panels 75 – 73 – 26 – 18 after removal of loose paint
